Rehabilitation plan

East Cove - Deal Island

Michael Comfort, Stuart Dudgeon and Cassie Strain
Friends of Deal Island (FODI)
December 2024

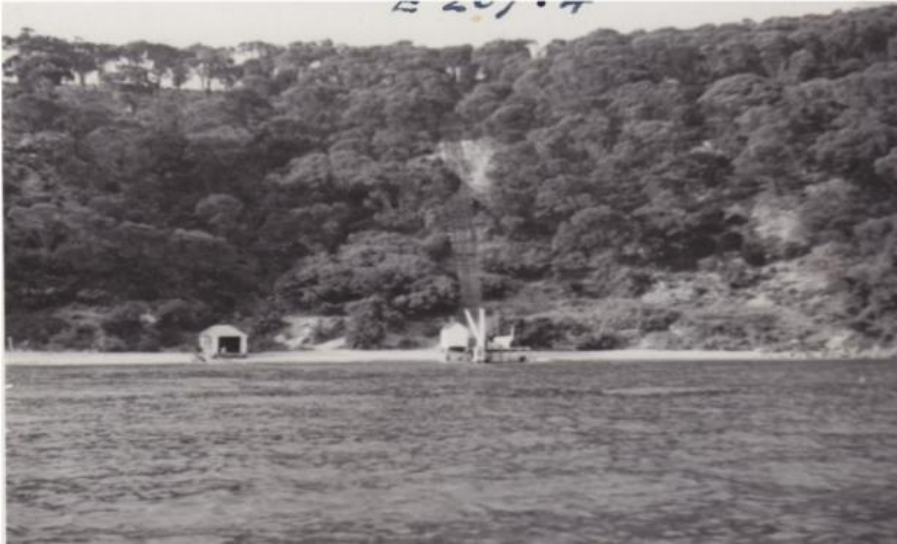
Figure 1. Historic photograph (circa 1940) of East Cove titled “A healthy weed free native vegetation - 70 years ago – can it be restored?” in Tyson and Tyson (2010).

From historic photos, it is clear that the bank at East Cove has in the past had a healthy cover of native vegetation (dominated by an overstorey of Drooping she-oak (*Allocasuarina verticillata*) and the current erosion is a relatively recent event. See Figure 1.

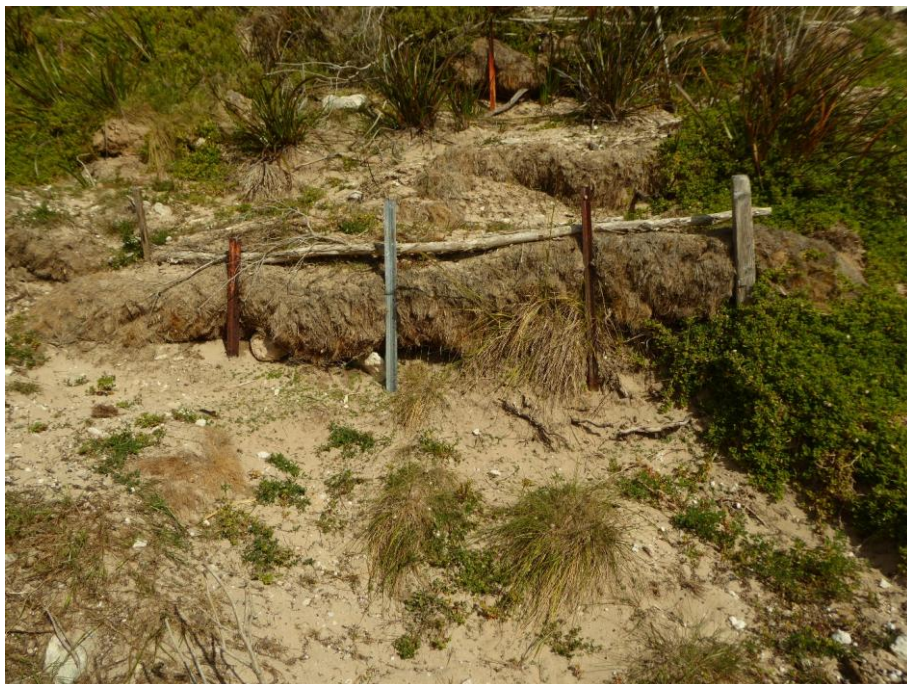
Figure 2. Current condition of erosion control structure that was installed probably about November 2012 on the East Cove slope. Photo M Comfort November 2024.

In addition to the weeding work and construction of the fenced enclosure FODI have undertaken other rehabilitation activities on the slope including installation of erosion control structures, placement of slash and some direct plantings. Log water bars were placed in 2011 (FODI 2011) and coir logs installed in 2012 (FODI 2012b) with additional ones in 2016. These structures are still in place and many are still being effective in reducing water flow on the slopes (Figure 2).

In the past, steel droppers were often used to anchor coir logs and timber water bars (Figure 2). Where these are no longer performing that role, the steel droppers could be removed from the slope. Hardwood garden stakes are recommended for any newly installed erosion control structures as they will break down over time.

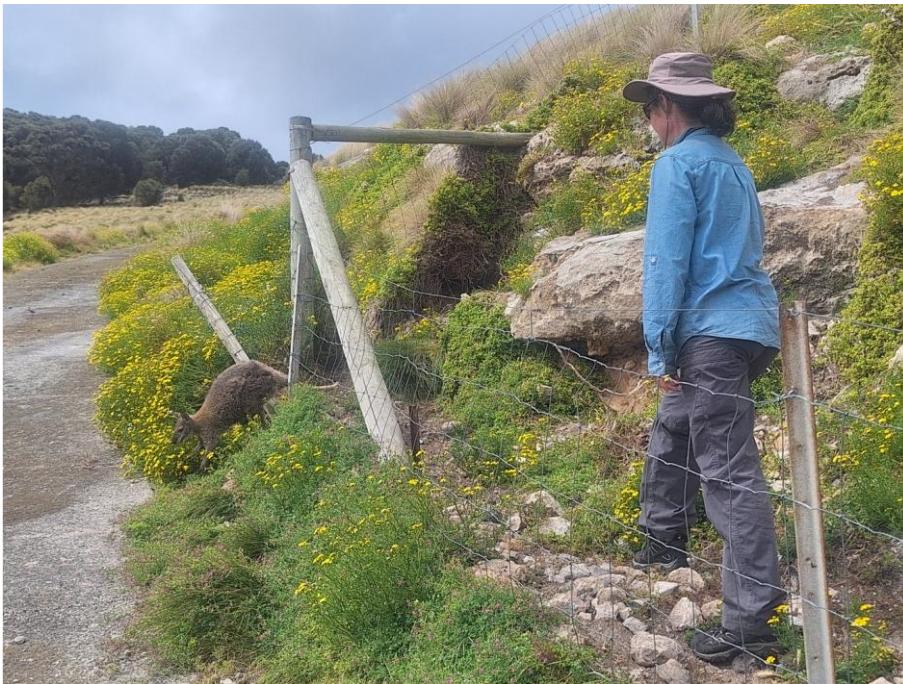
Figure 3. Cassie Strain (FODI Working Bee November 2024) encouraging a wallaby to leave the East Cove enclosure through an opened “gate” in the north east corner near a natural spring. Photo M Comfort November 2024.

A number of wallabies still remain within the fenced enclosure at East Cove and attempts to remove wallabies from the enclosure should be undertaken on an opportunistic basis. Experience from the November 2024 FODI Working Bee demonstrated that one of the most effective means to remove wallabies was by opening the “gates” at the north east and south east corners of the enclosure. There is a natural water spring near the north east corner adjacent to the road to East Cove and often one or two wallabies gather in this corner in the afternoons. By leaving the “gate” open in the afternoon wallabies can be encouraged to exit the enclosure (see Figure 3). In the south east corner, near the main gate at the top of the road leading down to East Cove a water container can be placed here to encourage wallabies and by using the temporary fence and opening the “gate” wallabies can be encouraged to leave the enclosure. FODI working bees should allow time to undertake this and it may be possible via PWS to encourage island caretakers to also help reduce the numbers of wallabies in the enclosure in this way.

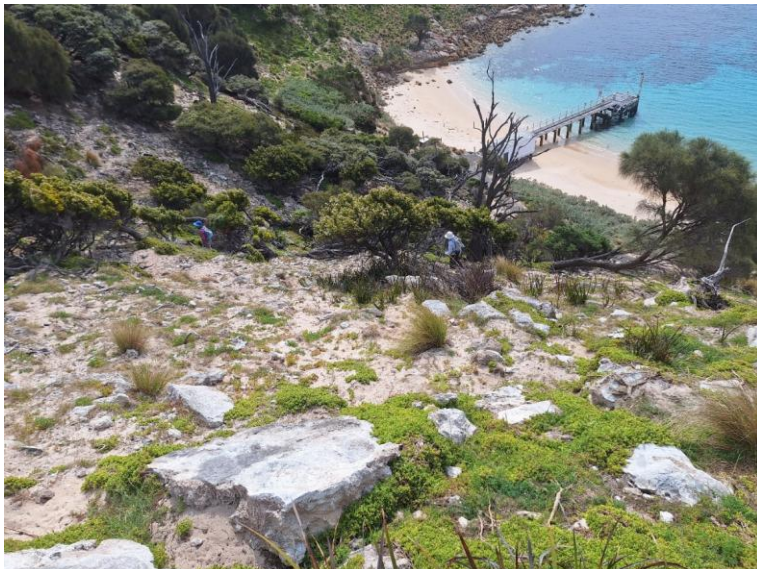
Figure 4. Proposed site for active rehabilitation erosion control works. The site is above the East Cove Jetty. The slope above this site is vegetated and work here will extend the area of stable revegetated ground on the East Cove slope. Photo M Comfort November 2024.

It is proposed to install a number of erosion control structures during the March 2025 FODI working bee to slow down erosion rates on the slope and further encourage revegetation. During the November 2024 FODI working bee the East Cove slope was surveyed and an initial site was determined to conduct these works (Figures 4 and 5). The site is at the upper end of the steeper slope with vegetated ground above and the area below has previously had some erosion control works installed. The GPS location for the site is: Easting 526790 / Northing 5630481. If time and resources allow additional nearby eroding areas could also be targeted.

It is proposed to use the jute matting to make a number of jute/slash “sausages” to be placed in a similar way to the coir logs targeting bare areas as identified above (Figures 4 and 5). Jute matting comes in tightly packed bales and is available through a rural supplier on Flinders Island. A jute bale comprises open weave matting 1.2m wide and 550m long. A single bale weighs approximately 340kg. Back loading of flights to Deal Island should be utilised to transport it and this will require liaison with PWS and the aviation company.

The East Cove site (Figures 4 and 5) is best approached from above from near the whim. Photo monitoring sites (see 6.3 above) need to be established and photographed prior to any on-ground works are undertaken.

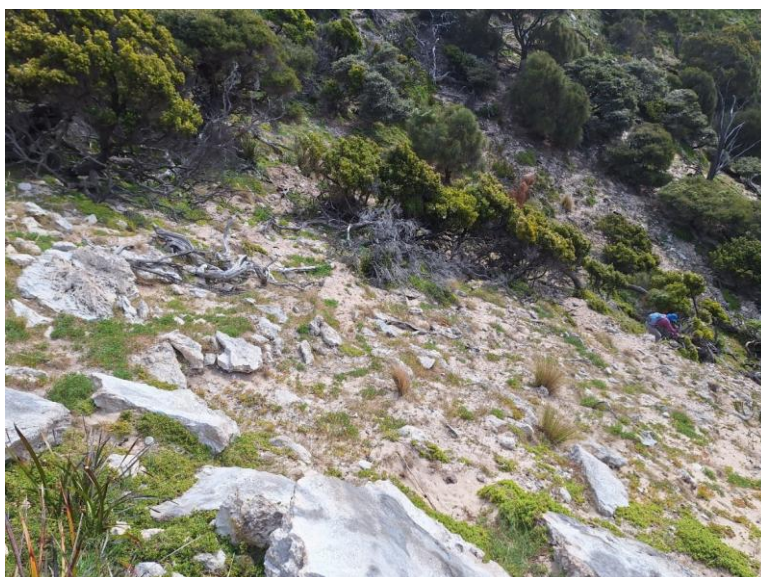
Figure 5. Another view of the proposed site for active rehabilitation erosion control works on the East Cove slope. Note person mid picture right hand side for scale. Photo M Comfort November 2024.
